## **Conservation of Hinemihi; Consultation document**

### **1.0 Introduction**

### **2.0 The Phases in Hinemihi's physical biography**

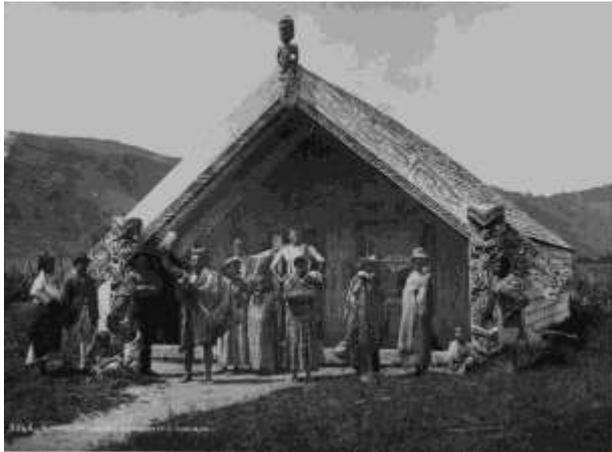
Figure 1. 1880 Hinemihi following her construction in Te Wairoa, North Island, New Zealand

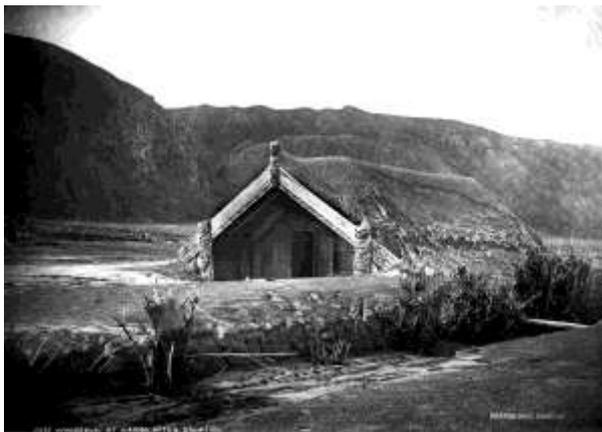
Figure 2. Hinemihi after the eruption of 1886.

- 2.3 On June 10<sup>th</sup> 1886, the eruption of Mount Tarawera destroyed Te Wairoa and the surrounding area. A number of people (30-50) were saved by sheltering inside Hinemihi during the eruption. In total 153 people died during the eruption. The local area was devastated and Hinemihi was left isolated (see figure 2).

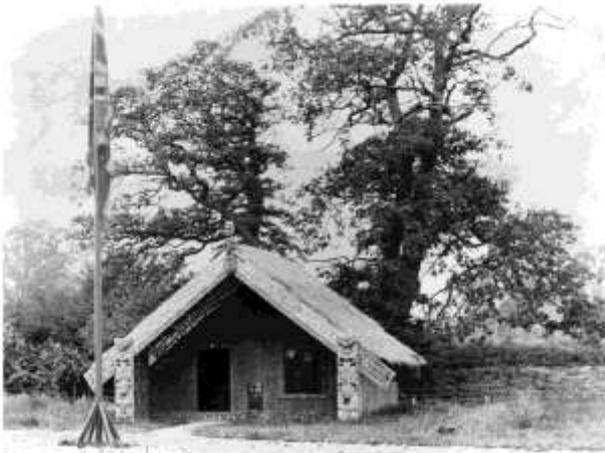
*Figure 3. 1917-1919 Hinemihi following work carried out during WW1 by recuperating soldiers*

2.6 In 1917 restoration work was conducted by recuperating WWI soldiers, including Maori National Expeditionary soldiers (Maori Pioneer Battalion). This resulted in a possible change of location for Hinemihi, or a change in position of the adjacent stream/lake (see figure 3).

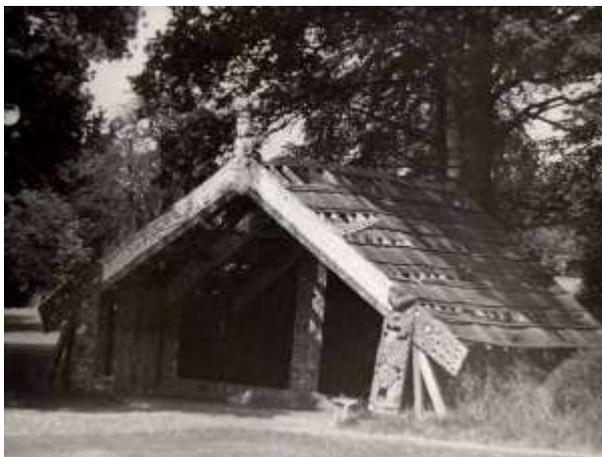
*Figure 4. 1919-1959 Hinemihi during this time her carvings were repainted, her front wall was lost and Hinemihi became an open structure*

2.7 Between 1919 and 1945, a major reconstruction of Hinemihi took place (for which no records have yet been found) her front wall was removed and an open structure created. A new roof was added at some stage, and additional heke tipi (internal barge boards) were added to Hinemihi's interior. The poutahu carving (interior front roof support) was turned so that its carving was facing outwards. The carvings were repainted, and the red/white design on the carvings was reversed. The design painted on the maihi (bargeboards) was altered. It is likely that the carvings from the partition wall (window frame carvings) were removed from the structure and were relocated to the attic of the main house at this time (see figure 4).

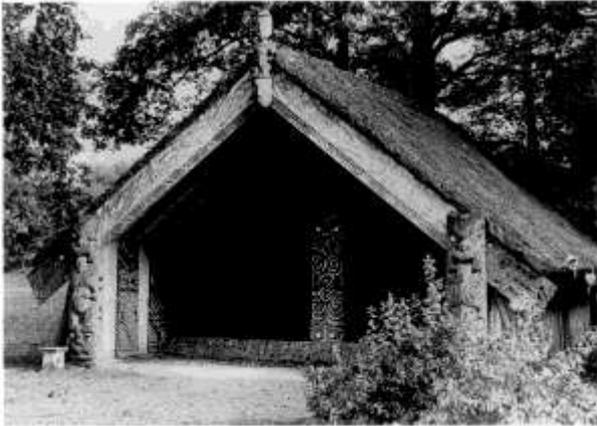
*Figure 5. 1960s Hinemihi following restoration in which a new roof was constructed, the carvings were repainting and the open structure retained.*

2.10 In 1960 a major restoration of Hinemihi took place. K. A. Webster provided technical advice for the refurbishment work. Cummings, a local building firm who were already working on the main house, were engaged to carry out the work. This included the installation of the current heke (rafters) and tahuhu (ridgepole), replacing the pre-existing roof timbers. The internal woven matting panels, the birch bark saplings that line the interior roof, and possibly the external elm boarding, were added at this time (although it is possible that the external boarding was reused from the earlier Hinemihi). A new straw thatch roof was applied. The decorative designs on the heke (rafters) were painted at this time and it is likely that the other carvings were also repainted along with the addition of replacement paua shells to eyes of the carvings (see figure 5).

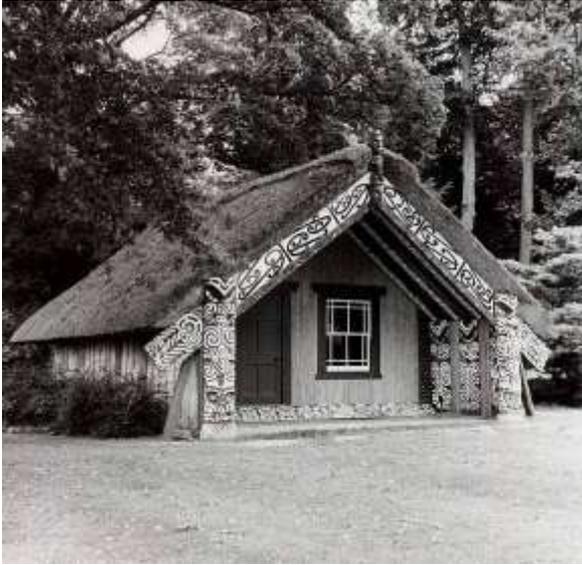
Figure 6. 1980s Hinemihi following restoration by Draper & Sons in which repainting of the carvings took place, and most significantly, a new front wall was added.

2.12 In 1980 Draper & Sons - a building firm specialising in historic timber buildings - refurbished Hinemihi. A new front wall, door, and window were added. The poutahu (interior front roof support) was turned around to its correct position. The carvings were cleaned and repainted, and the red/white colour scheme (from the 1960's) was reversed to match the original 1880's white/red scheme. The concrete base was reformed where it was crumbling, lead membranes were added underneath the amo. A drainage trench was dug around Hinemihi's perimeter. Birch saplings were added to the underside of the roof, paua shells were reattached to the carvings. A thick reed thatch roof replaced the thinner straw thatch roof (see figure 6).

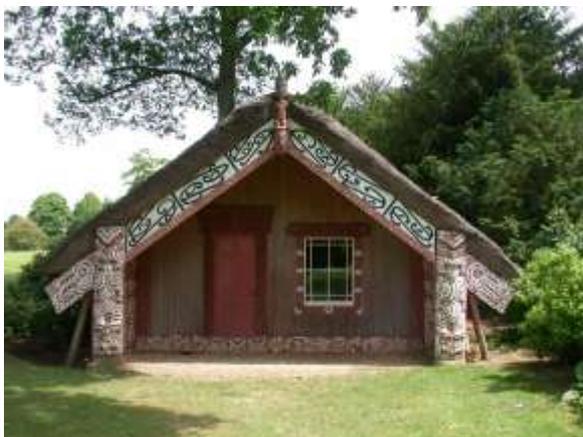
Figure 7. 1995 Hinemihi following involvement of Ngati Hinemihi and some restoration by Bob, Jim and Cathy Schuster, including the gift of new carvings created by Robert Rika and Colin Tihi

- 2.13 In 1995 Thirty members of Ngati Hinemihi travelled to Clandon Park to give newly created carvings to Hinemihi. They included; Robert Rika, Julia Rika, Colin Tihi, Jeff Crook, and Revd. Robert Schuster. Following a blessing ceremony, the new carvings, along with the recently discovered original carvings from around the window, were added to Hinemihi. Bob, Jim and Cathy Schuster conducted restoration work on Hinemihi prior to the dedication ceremony. This included some adjustments of the positions of the paepae (porch threshold) and maihi. Replacement of birch saplings in the porch with bamboo (closest locally available material to the traditional toe toe reeds) was carried out, as was cleaning and repainting of certain sections of the amo and raparapa (projecting ends of the maihi) (see figure 7).
